THE ORIENTAL INSTITUTE of THE UNIVERSITY OF CHICAGO
ORIENTAL INSTITUTE COMMUNICATIONS, NO. 16

TELL ASMAR, KHAFAJE
AND KHORSABAD

SECOND PRELIMINARY REPORT
OF THE
IRAQ EXPEDITION

By
HENRI FRANKFORT

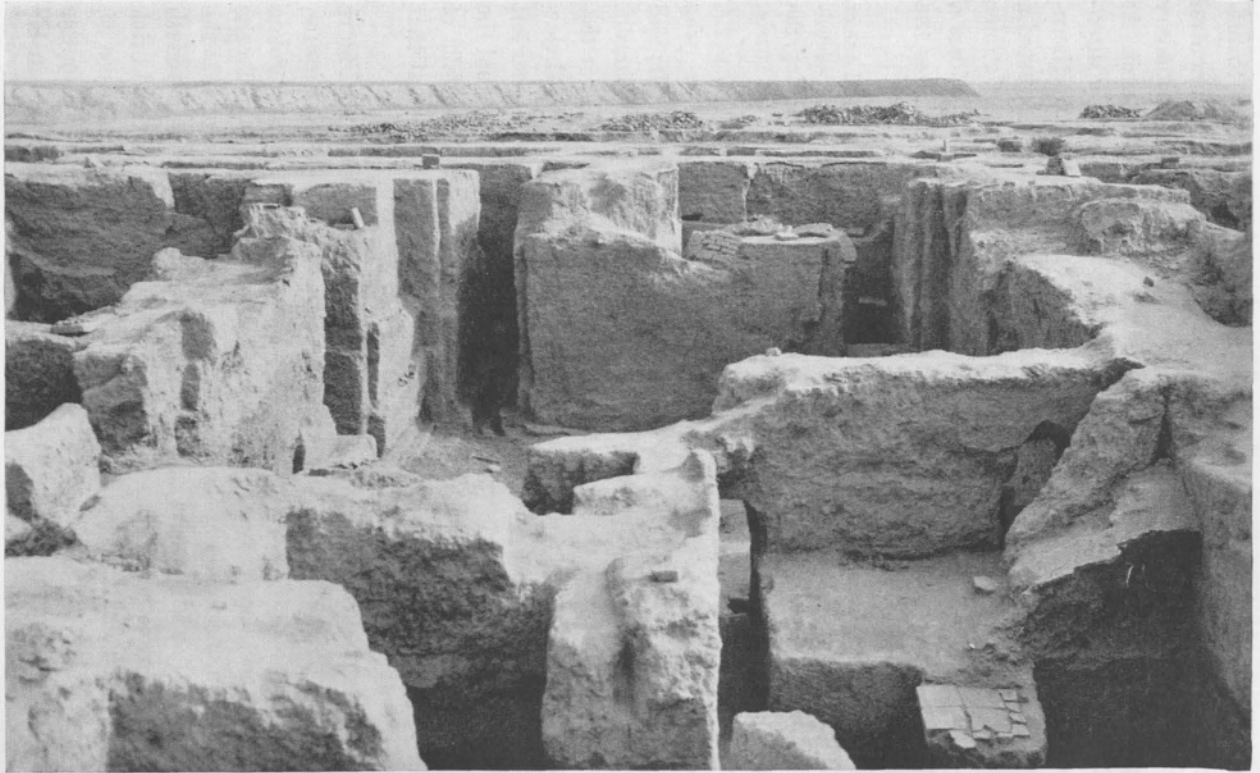
FIG. 4.—The courtyard of the Gimilsin temple, from southwest

rooms (cf. Figs. 3 and 16). On the extreme right edge of the picture is the entrance to the anteroom, 1 P 31, in which the drain was built later (cf. p. 4). In the background is the round well (1 P 30) built by Ibal-pel,⁸ which destroyed the earlier structures at that point.

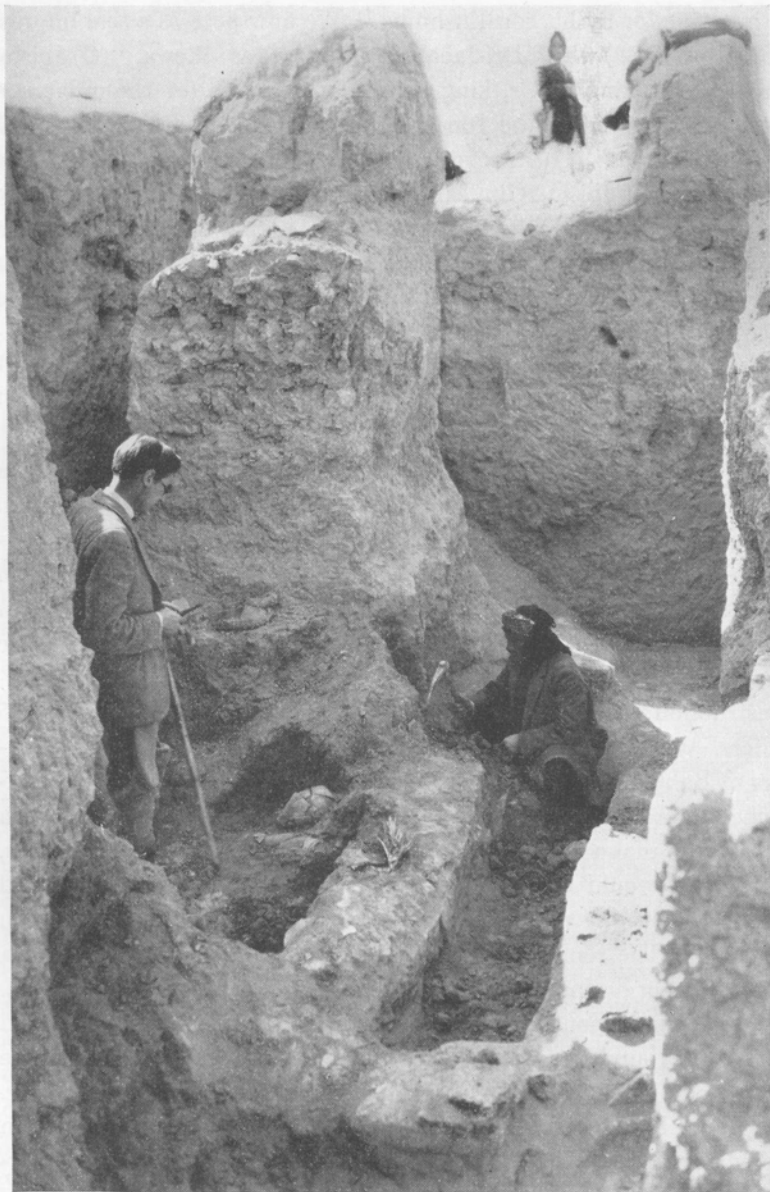
FIG. 9.—The platform in front of the niche in the cella of the palace chapel being disengaged from the retaining wall built across it by Nurakhum, from north-east.

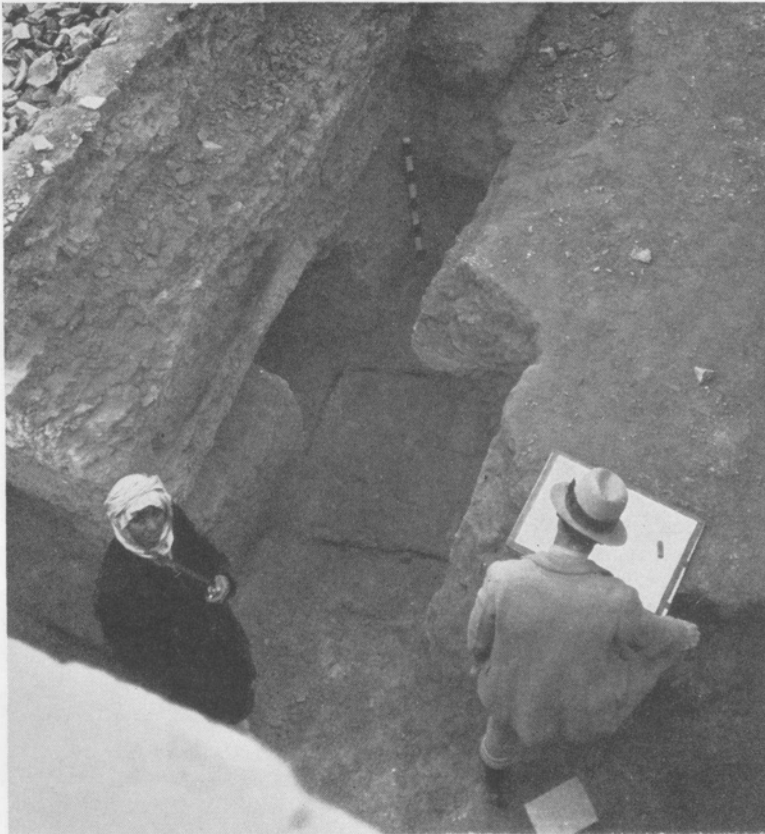
FIG. 12.—The ablu-tion slab in front of the door leading from Ilushuilia's palace toward the palace chapel. Above this is the remainder of the Bilalama wall, which contains no door at this point (cf. Fig. 16) but stands only 20 cm. high. The remainder of the wall shown here consists of foundations put down by Urninmar.

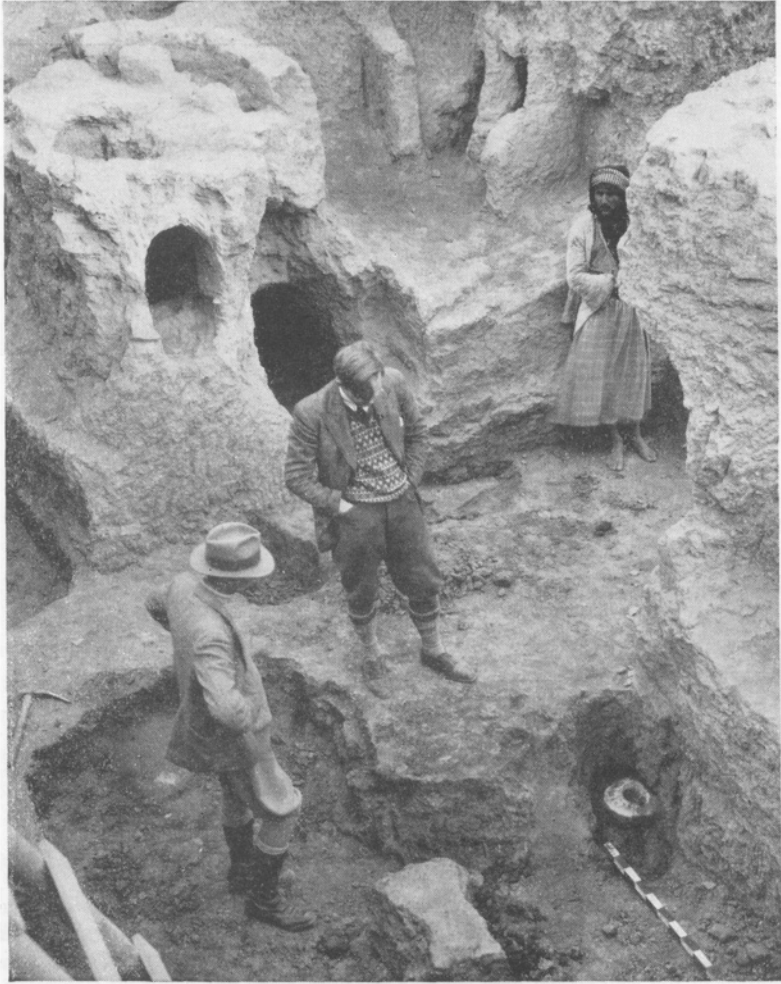
FIG. 13.—One of the pivot stones in the sanctuary of the Gimilsin temple after removal of the mud brick "box" which surrounded it. In the background is a smelting furnace erected after the conflagration.

pivot of the door passed to rest upon the stone below. Figure 13 shows one of these stones after the box had been removed. The doors of the cella could not be opened farther than is shown in Figure 3. Behind the left (western) door we found traces of a screen of reeds imbedded

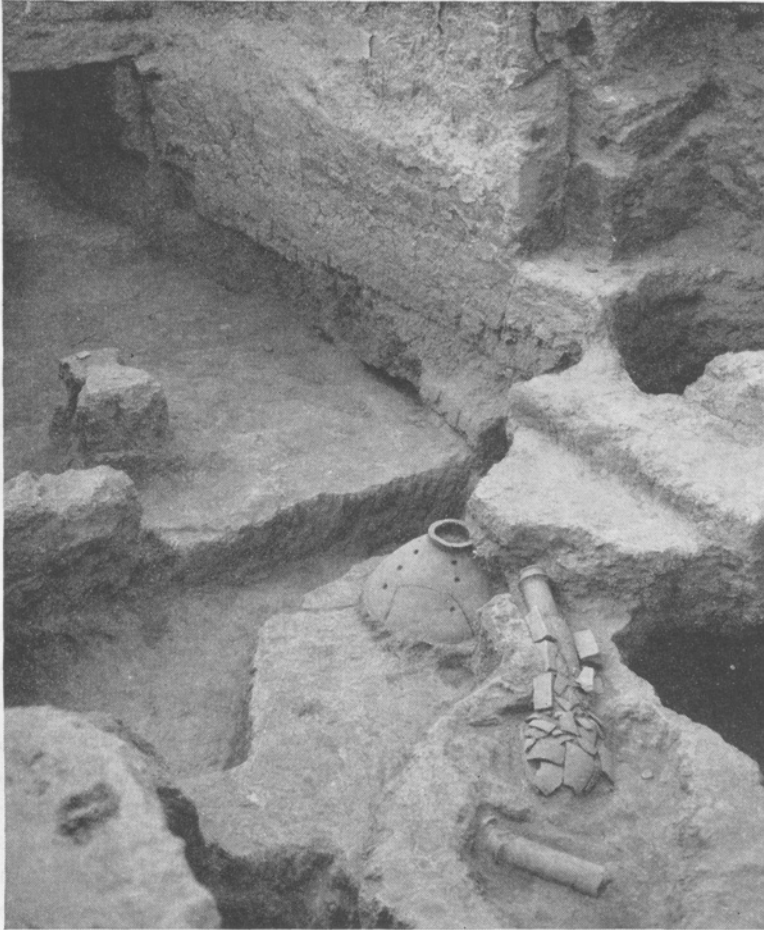
FIG. 14.—Pottery drains in the pavement in front of the niche in the cella of the Gimilsin temple. The hole dug in the platform was made by ancient robbers digging for the foundation deposit.

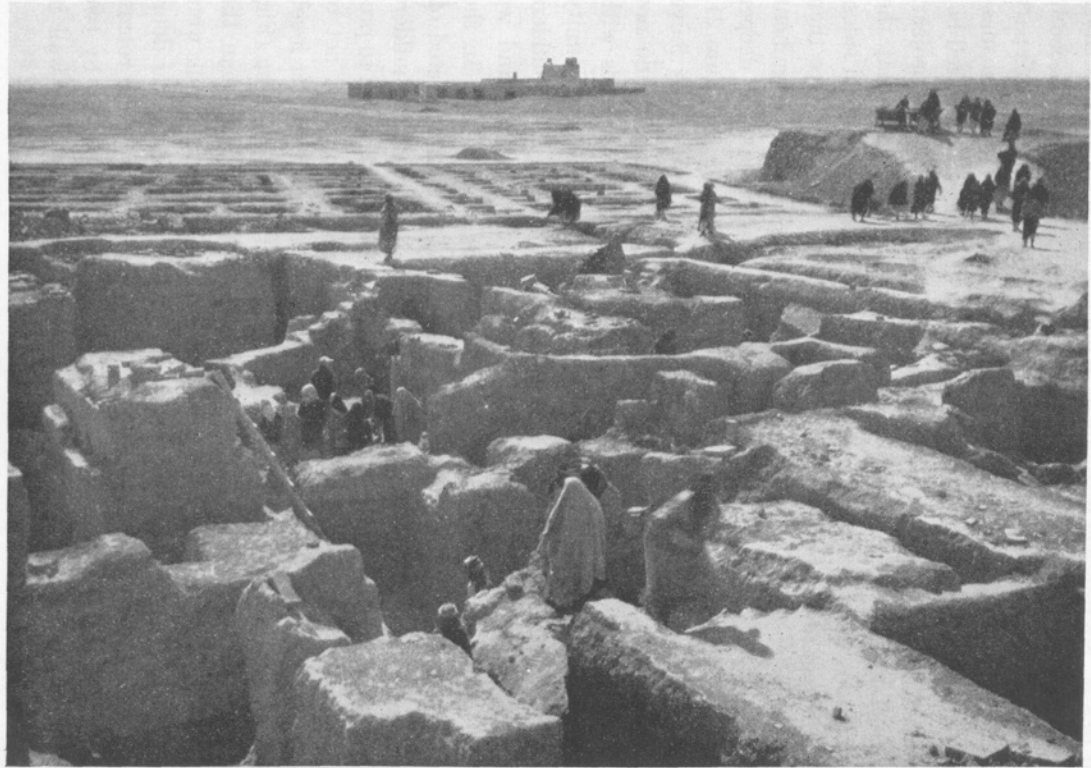
FIG. 22.—The western end of the southern building, shown beyond the palace, the clearing of which is nearing completion. In the background is the expedition house.

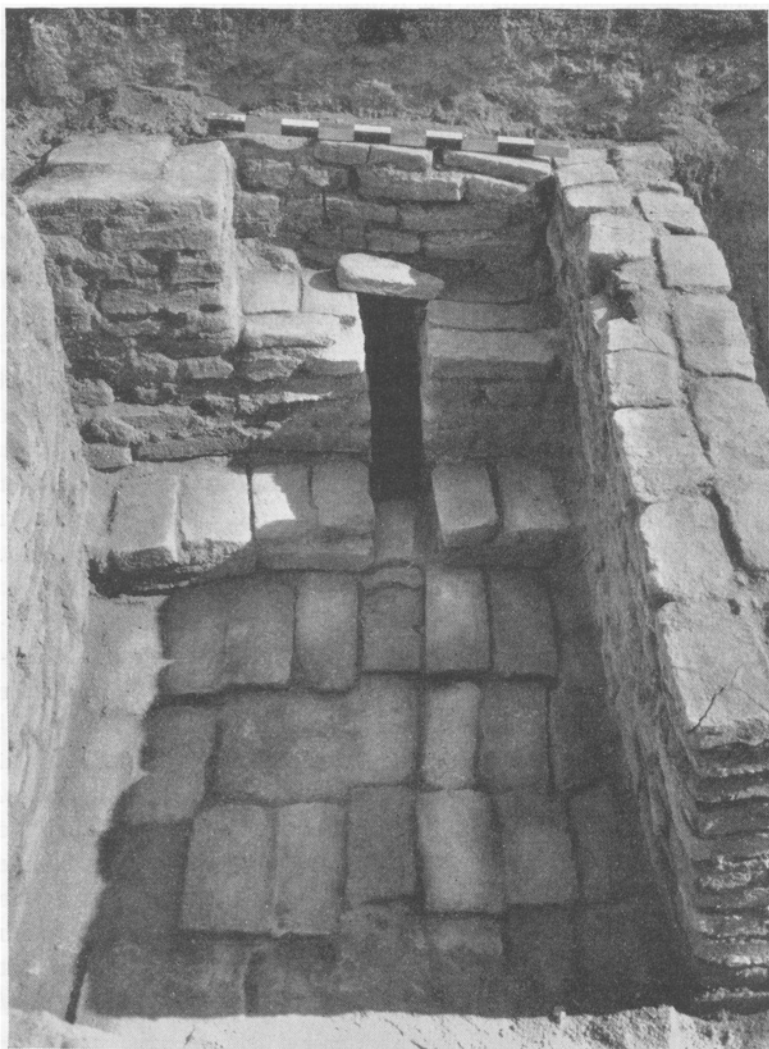
FIG. 23.—Privy in an Akkadian building

At the north end of this long stretch of ground Mr. Delougaz found some walls immediately below the surface. It soon became clear that they were so large and regular that they could not belong to mere private houses. A system of regular rooms and courts was disclosed. The surface finds had made us assume, provisionally, an early date for this part of the site. This was confirmed not only by a few cylinder seals but also by a scrutiny of the bricks of which the walls were built. They were rather small, measuring about 15×30 cm., and from 5 to 7 cm. thick. Most of them were flat on both sides, but some were decidedly plano-convex, though they bore no fingermarks.³ This establishes the date of our edifice with some precision: it belongs to the end of the early dynastic period, is decidedly pre-Sargonid, and probably was built by a northern contemporary of Entemena of Lagash. The discovery of a monumental building of this period is important. This structure presents a number of interesting features which we shall discuss more fully when we have finished excavating it. Three privies found here are, to my knowledge, the earliest ever found. One is shown in Figure 23. It is built entirely of baked bricks, with which the lower parts of the walls of the room are also lined. Underneath it runs a large vaulted drain of baked bricks, which serves another privy

built up against the back wall of the one shown in our picture. This drain was big enough to allow a boy to be sent through it for periodical

cleanings. The main drain ran outside, parallel with the outer wall of the building, and the various drains within were connected with it.

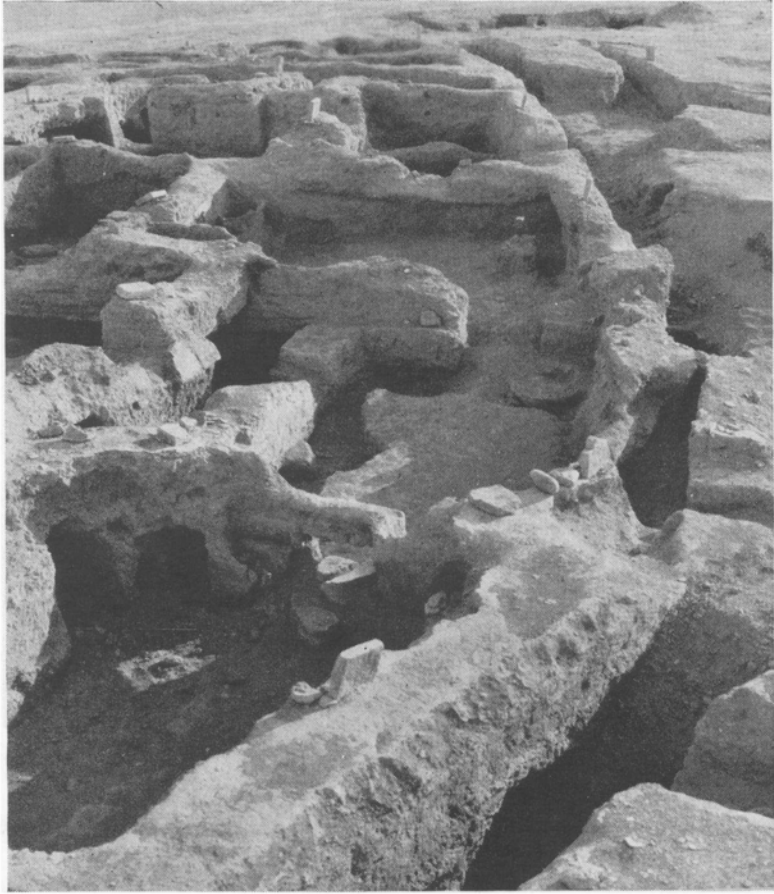
FIG. 25.—View from the east across private houses, showing the street on the right and the walls of three successive building periods.

The depression southeast of this hillock covers the site where from time immemorial a street seems to have run. Beyond the street there is a maze of small walls belonging to private houses (Fig. 25). The excavation of these houses was continued throughout the season, first under Mr. Loud and then under Dr. Jacobsen. To excavate them was a difficult task at best. Instead of the large and generally consistent reconstructions which mark the successive periods in the existence of a public building, the private houses reflect the limitation of their

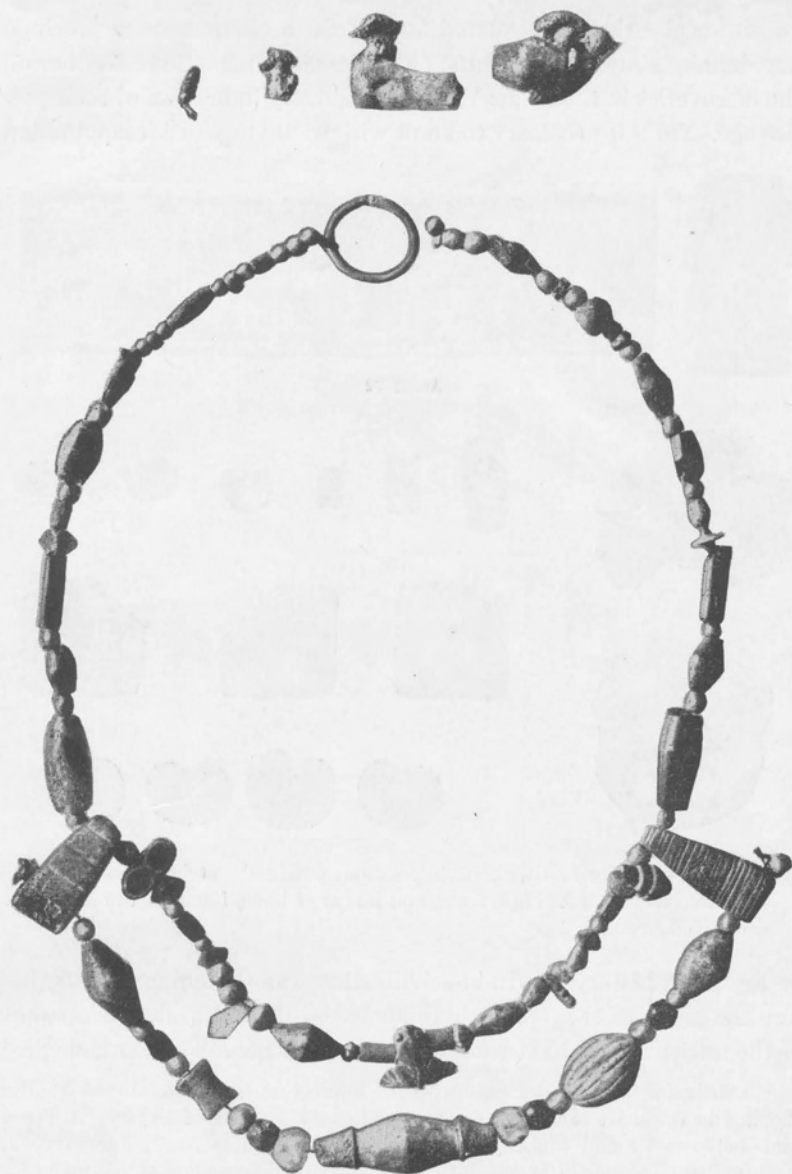
FIG. 31.—Necklace of stone and silver beads. Above, silver beads in the condition in which they were found. Scale, 4:5.

The contents of one of these pots have been restrung as a complete necklace (Fig. 31). Most of the beads are of lapis lazuli, some of carnelian, and some of rock crystal. The two center pieces are a frog of silver and a large lapis lazuli bead with silver caps. The illustration shows how well the silver has been restored to its original brilliance by Mr. Delougaz' skilful treatment in the Tell Asmar laboratory; a few of the silver beads are to be seen at the top of Figure 31 in the condition in which they were found. In the circle, near the left-hand pendant by which the part-circle is suspended, may be seen an elliptical carnelian bead with white etched lines. We assume that it was used to pair with the red and white shell shown in a similar position at the right.⁸ Etched beads are rare, but they have been found at Ur and Kish. They have been the subject of a special study by Mr. Ernest Mackay,⁹ who drew attention to the fact that such beads are found, though not in great numbers, at Mohenjo Daro.

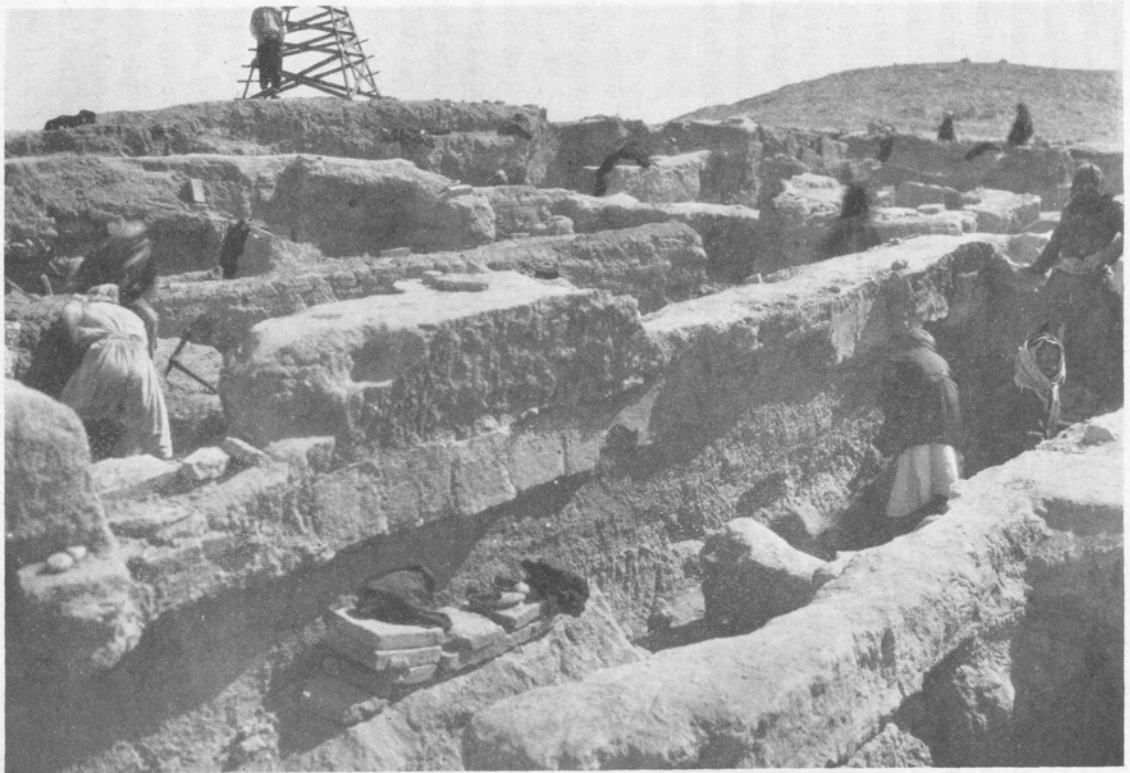
FIG. 34.—Suburban houses of the Larsa period superimposed upon Akkadian ruins of two periods

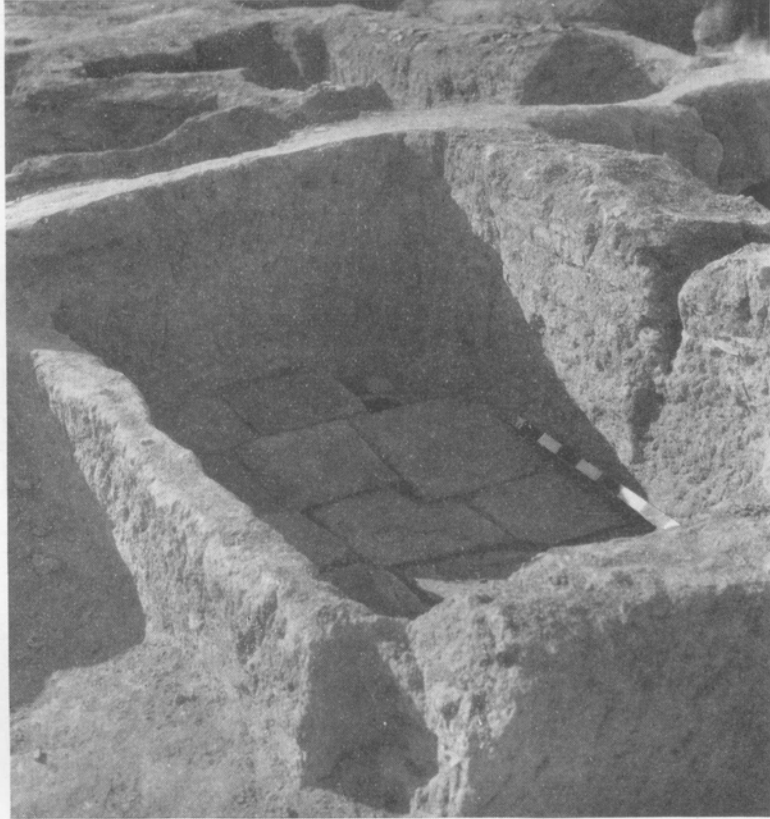
FIG. 35.—Bathroom in a house of the Larsa period in which temple bricks of Shulgi were re-used.

Now a bathroom in one of these houses of the Larsa period was paved with baked bricks (Fig. 35). They were originally intended for

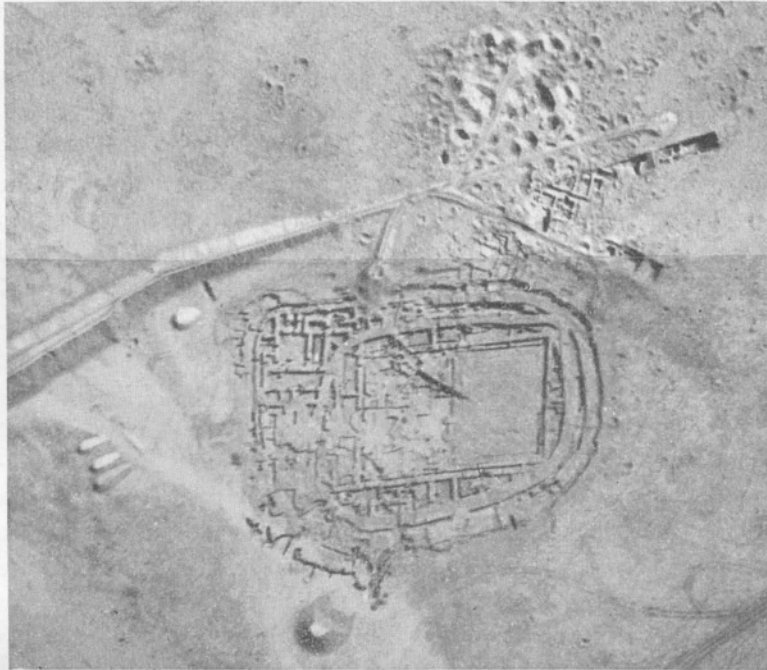
FIG. 39.—Air view of the excavations at Khafaje

Our immediate aims were indicated by the work of the preceding season: it was necessary to complete the outline of the "oval" and to explore the area which it inclosed (Fig. 39). Only then could we think of descending into somewhat deeper layers in order to disentangle the sequence in time represented by the various remains. The earlier report has already drawn attention to the slope of the ground and the consequent disappearance of the remains of the oval inclosure wall in the southwest.⁶ The situation at the western end of the oval proved to be

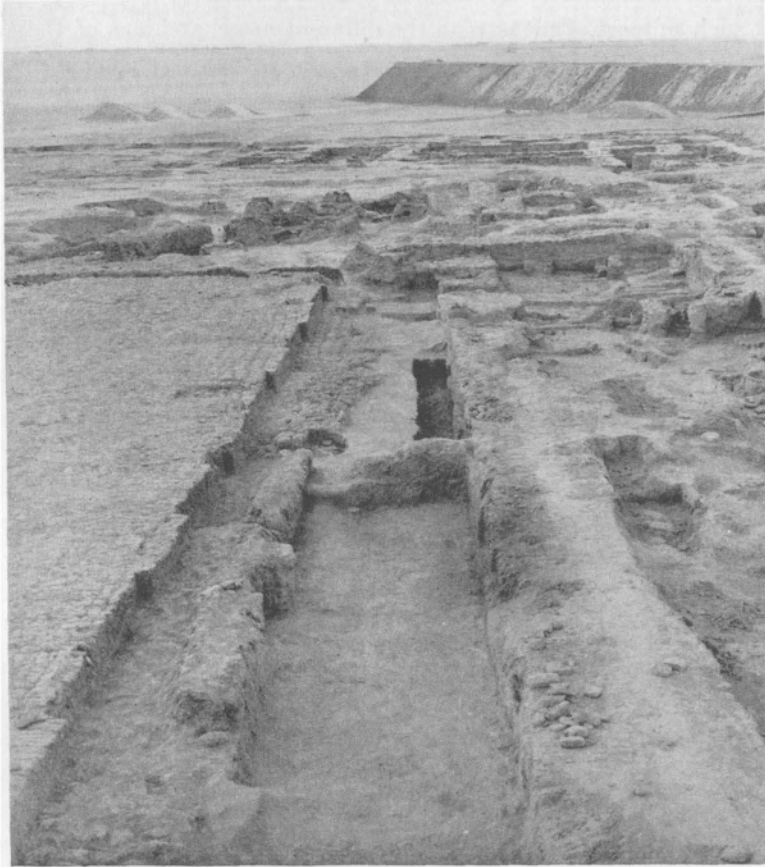
FIG. 41.—The earliest temple platform, appearing below a later platform (left); the northwest wall of the temple courtyard (right).

of those which we have been discussing, seems to be indicated by remains on the northeastern side of this platform (solid black on the plan). At first it was thought that this brickwork formed a foundation platform for the buttressed building (Fig. 41), but it appears to turn at right angles, disappearing beneath the northern corner buttress. At

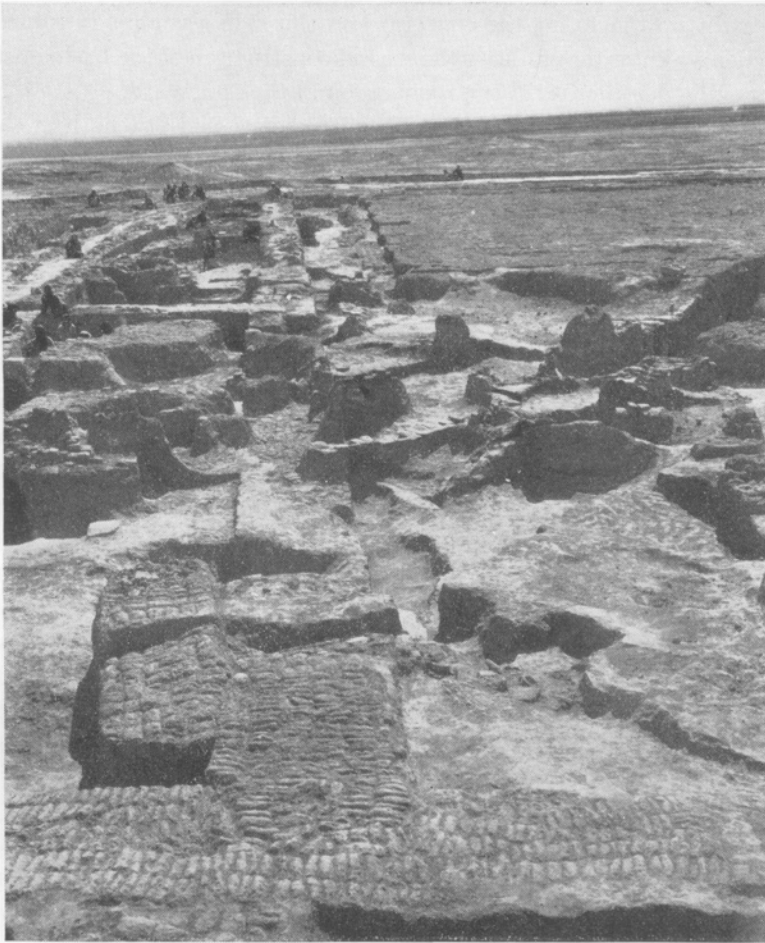
FIG. 42.—The temple platform (right background) and the northeast wall of the temple courtyard (running straight from foreground to background), on the right of which is the round basin. The oval inclosure wall shows in the left background.

At the time of the excavation of the baked brick basin in M 44 during the first season's work, it was unfortunately isolated from its surroundings (cf. Fig. 42). It was shown, however, that the basin had

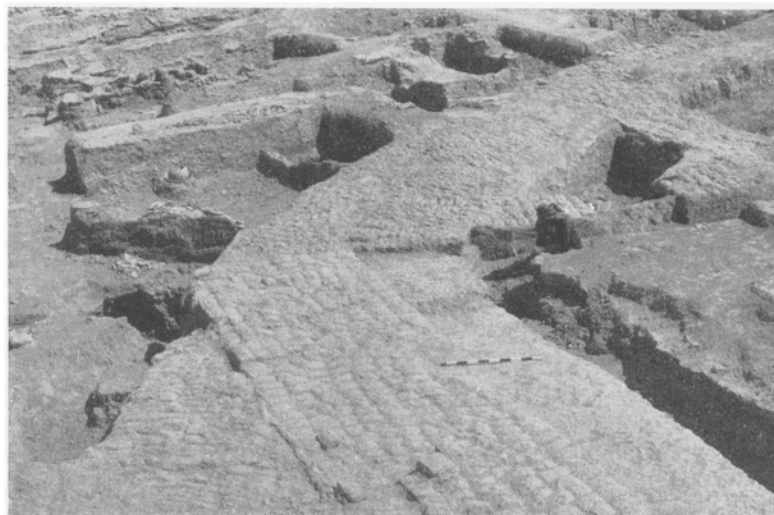
FIG. 45.—Northern half of L 44, from southwest. The earliest oval inclosure wall runs from the upper right to the lower left corner. Two rebuildings, both attempting to achieve a straight-lined plan, can be seen in the foreground, the later one of well laid bricks and the earlier one (on the right) covered with mud mortar. House D is seen in the background.

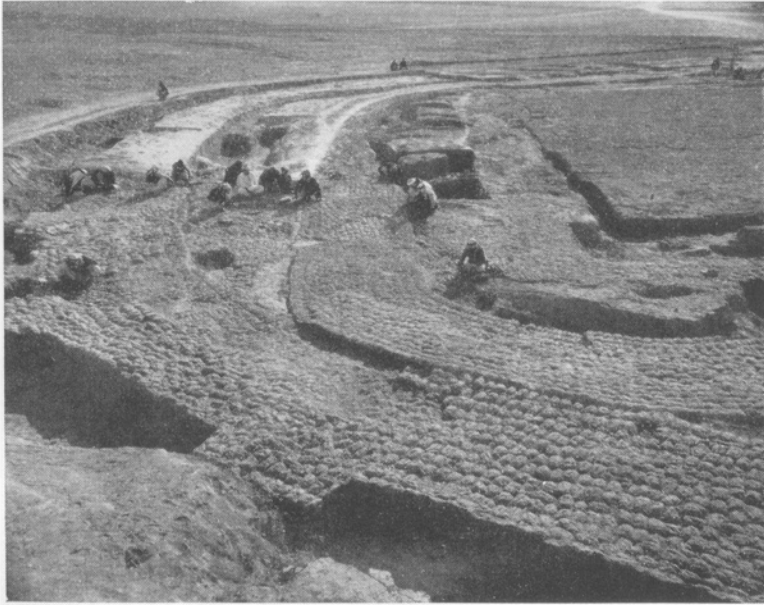
FIG. 46.—General view across the southeast part of the excavations, showing from left to right the oval "outer inclosure wall," the late straightened wall, the wall of the temple courtyard, and the temple platform.

earlier stages of the building's history (Fig. 46). This wall represents the latest period which we can trace by architectural remains in the eastern part of the oval. We do not know whether the gate, which represents the latest period traceable in the west, belongs to the same structure. In order not to include hypotheses in our plan, we have given different markings to these two groups.

The "outer inclosure wall" seems not to have been entirely ruined when the straightened wall (formerly called the "hooked wall") was built, for the latter touches its inner face at the corner without cutting into it. At this point we obtain therefore a succession in time of "inner inclosure wall," "outer inclosure wall," and straightened wall. As we have said, we can tentatively correlate these periods with the three periods observed in the temple platform, and this we have indicated by corresponding hatchings on the plan (Fig. 40).

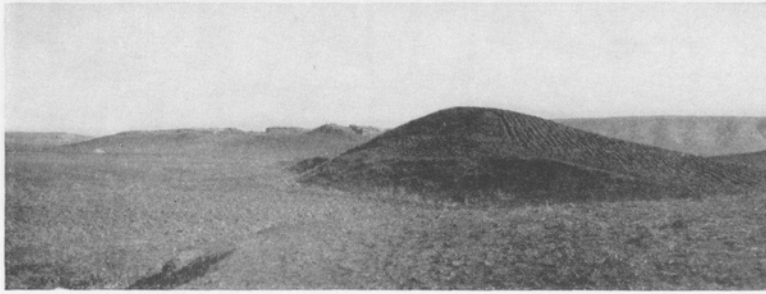
FIG. 52.—Town Gate 7 (right foreground) before excavation. In the background is the hill upon which the ruins of Sargon's palace are visible.

During our first season (1929/30) we excavated Place's Gate 7 (Figs. 51-52), to the southwest of the palace hill, because it was the only town gate not touched by our French predecessor and therefore it offered a good opportunity to test the accuracy of his work. At the same time, since we knew from Place's plans of the other gates what to expect, it was a favorable place in which to start work with a staff in need of experience.

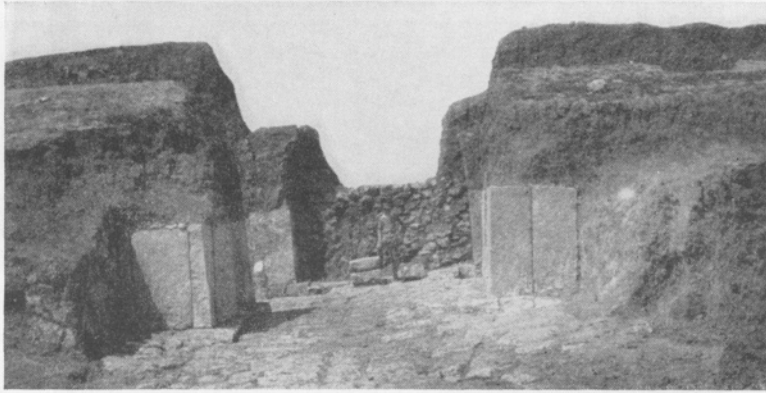
FIG. 54.—Gate 7 as seen from the town side

possible (Figs. 53-54). It was whitewashed inside, as was all of the outer and inner brickwork. That the gate chamber had been roofed in and was not an open court was established by a scrutiny of traces of decayed fibrous remains which turned up among the masses of fallen brickwork. Some of the fibers were white, others black; occasionally there were clear traces of red paint adhering to them. Their structure often showed the grain of wood; at other times, the texture of matting. Some of the pieces measured as much as 75 cm. across. The remains of mats sometimes showed a convex surface, produced presumably by their sagging under the weight of superimposed layers. The most satisfactory reconstruction leads us to assume that roofing beams were placed about 26 cm. apart and were covered with mats. Upon these a layer of mud was placed, then more mats, and another layer of mud. This was covered with either the tamped mud forming the floor of a

These discoveries alone add to the information contained in Place's plans sufficient new details to reward our labor at the gate. We have yet to refer to the observation of another fact of considerable general interest. We found that the gateway was blocked with stones (Fig. 54). This was not a makeshift after theft or removal of the wooden doors, for the latter had never been put into place. Two paving blocks were piled neatly behind the barrier. Two more blocks, one on each side, stood on edge (only one shows in Fig. 54). The latter were cut out on one side, ready to be let down over the pivot stones and closed around the pivots of the doors when these were put into place (Fig. 55). But the pivot stones showed no signs of wear. They had never

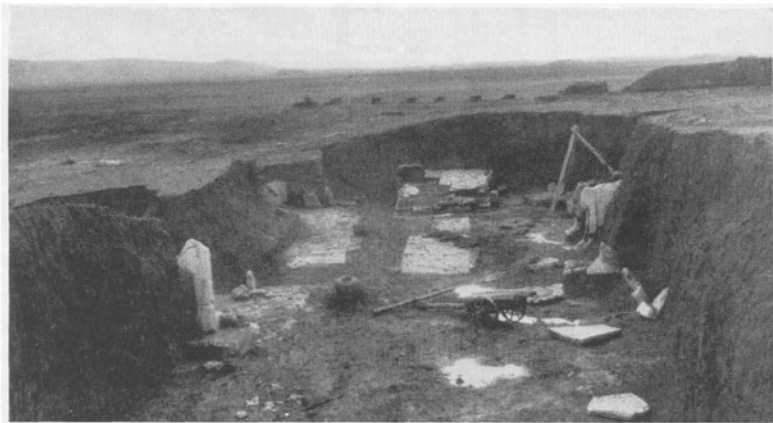
FIG. 59.—The throne room in Sargon's palace, from northwest

The throne room can best be understood from a comparison of Figure 59 with Figure 57. On the left in Figure 59 is the central entrance from Court VIII. The white stone fragment still standing is a portion of one of a pair of relatively small human-headed bulls which formed the sides of the entrance. The colossal bull now in Chicago stood immediately outside this gateway. The wall running toward the foreground was originally covered with sculptured slabs which have now disappeared. Beyond the central entrance one sees a pavement of baked bricks, which may be a secondary feature of this room, and traces of another entrance into the court. A third entrance is just

mains of a huge monolith, 6 meters wide and perhaps 8 meters high, which formed a shallow niche in the wall. In the background of Figure 59 are shown the remains of a similar monolithic niche, before which lies an enormous monolithic base for the throne. This base, now badly

damaged, measured originally 4×5 meters and was almost 1.50 meters thick. The sides of the throne base are sculptured. On the west side appear Sargon's archers attacking a mountain city. On the other side the king halts his chariot on the battlefield above the body of a fallen enemy, while officers pile up before him a pyramid of heads (Fig. 60). A pavement of stone slabs measuring 2×4 meters each, laid through the middle of the room and surrounded by a tamped-mud floor, led up to the throne (Fig. 59).

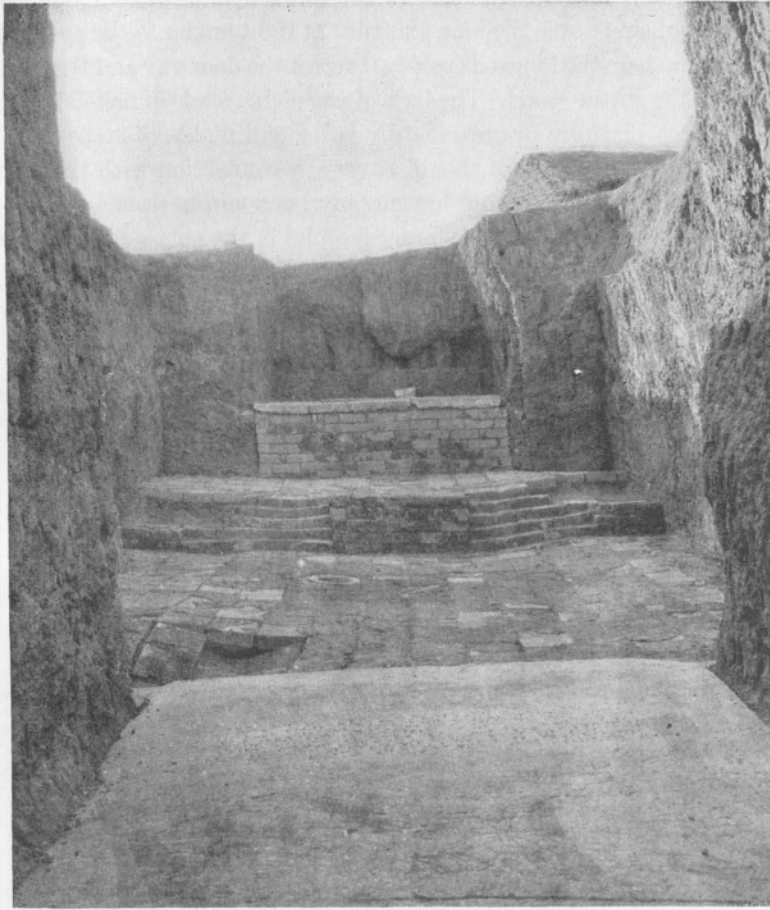
FIG. 66.—The temple of Adad in Sargon's palace. The doorsill in the foreground is inscribed with a prayer.

center but at each front corner. In one of the temples excavated in 1931/32 the same arrangement was found (cf. Fig. 66).

One of the smaller temples, which Place mistook for a bedchamber, is shown in Figure 66. We see in the foreground a large doorsill inscribed with a prayer addressed by Sargon to Adad. The room is en-
